# Bridgehill Residences

**Project:** Trade Assist Services - Cladding Replacement

## Total Façade Management

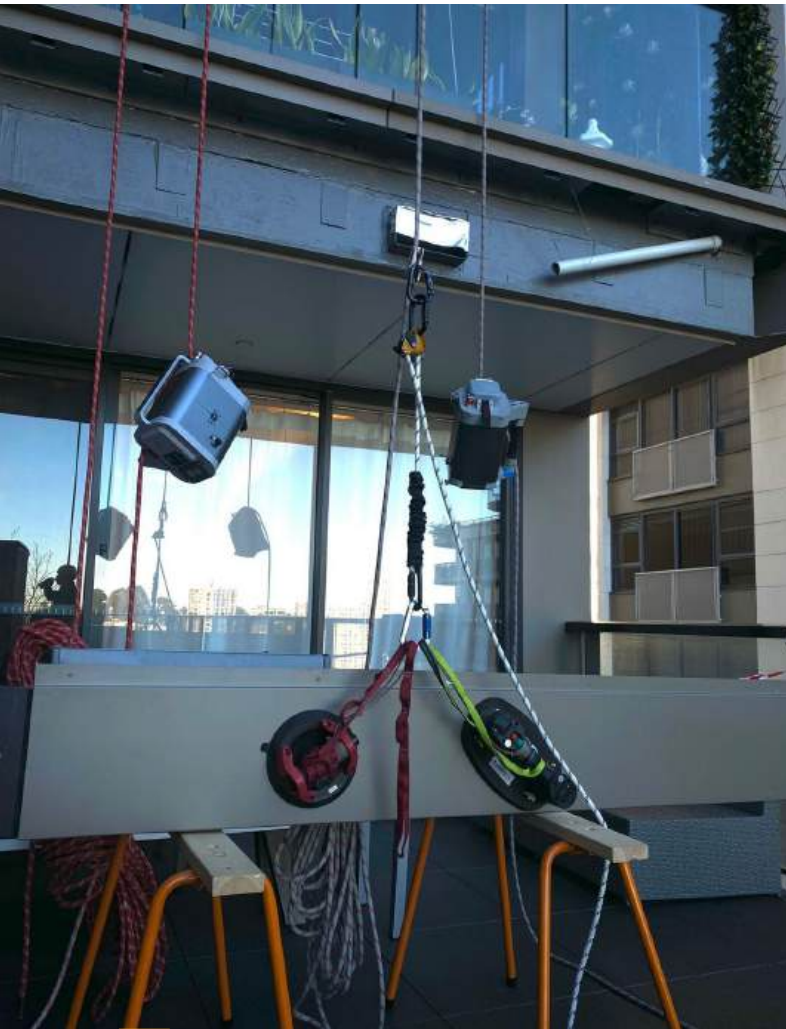
Facade cladding technical rigging for safe transfer from ground

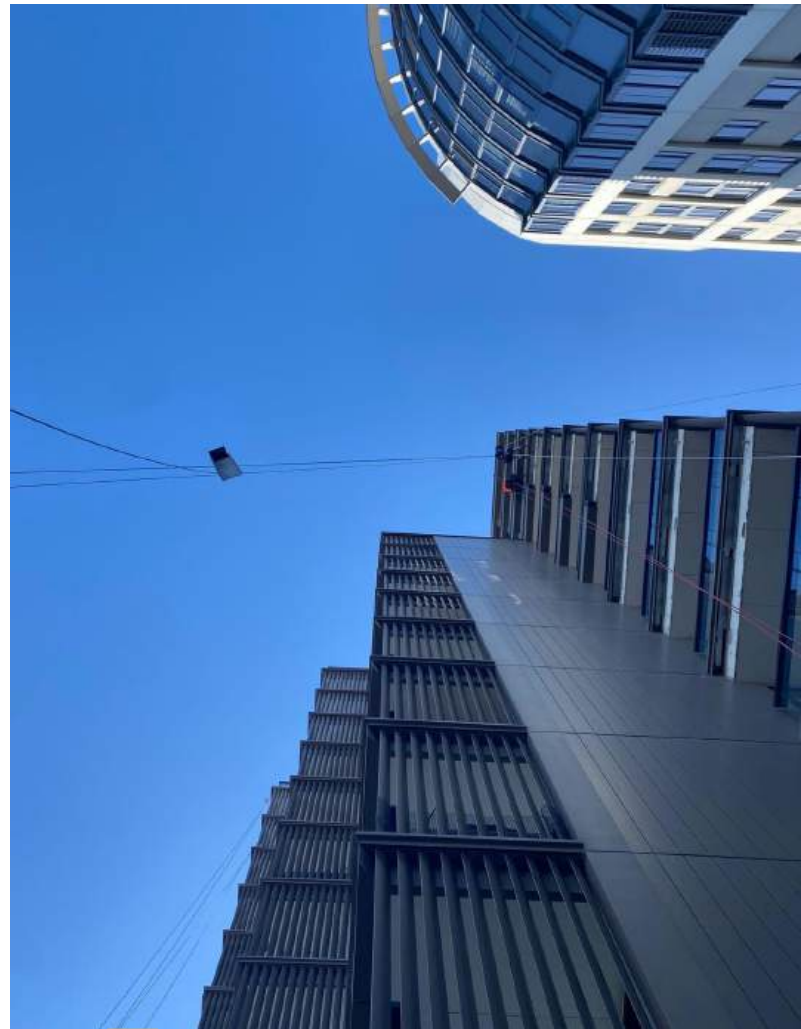
Facade cladding transfer from ground to technicians on the ropes.

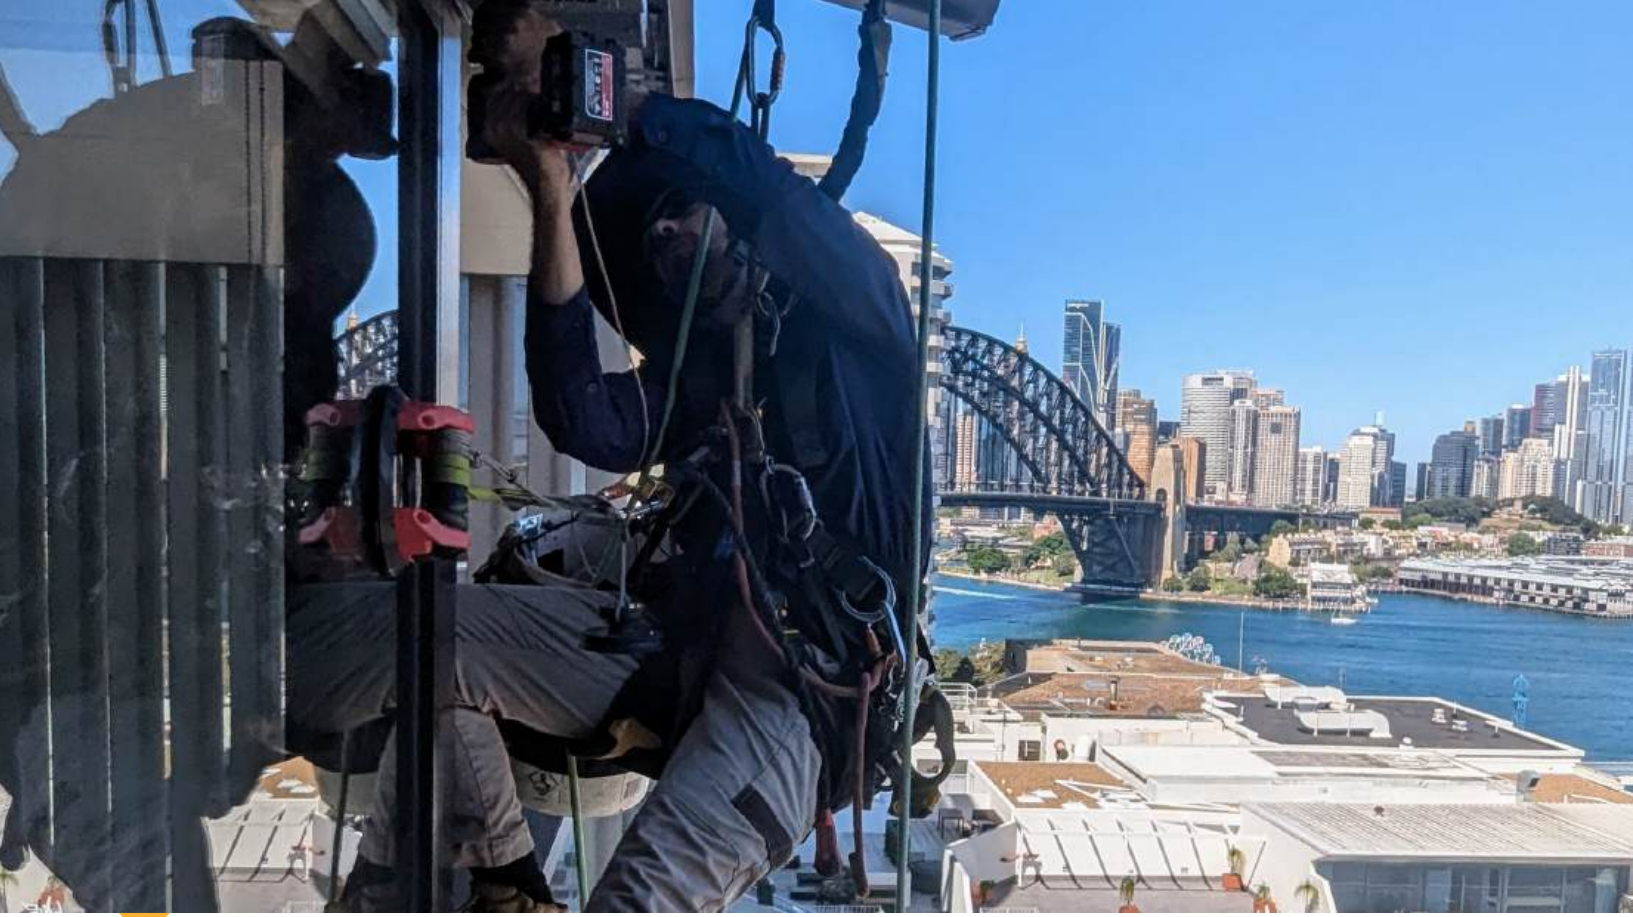
Rope access technicians adjusting gaps in the cladding panel tracks

1. Gaps in the cladding panel tracks – Additional fixings were installed to ensure a secure fit, eliminating rattling sounds
2. Installation of ventilation grilles – Air was previously trapped within the cladding, allowing odours to circulate between apartments. We integrated the panels with each apartment's exhaust system to resolve this issue.

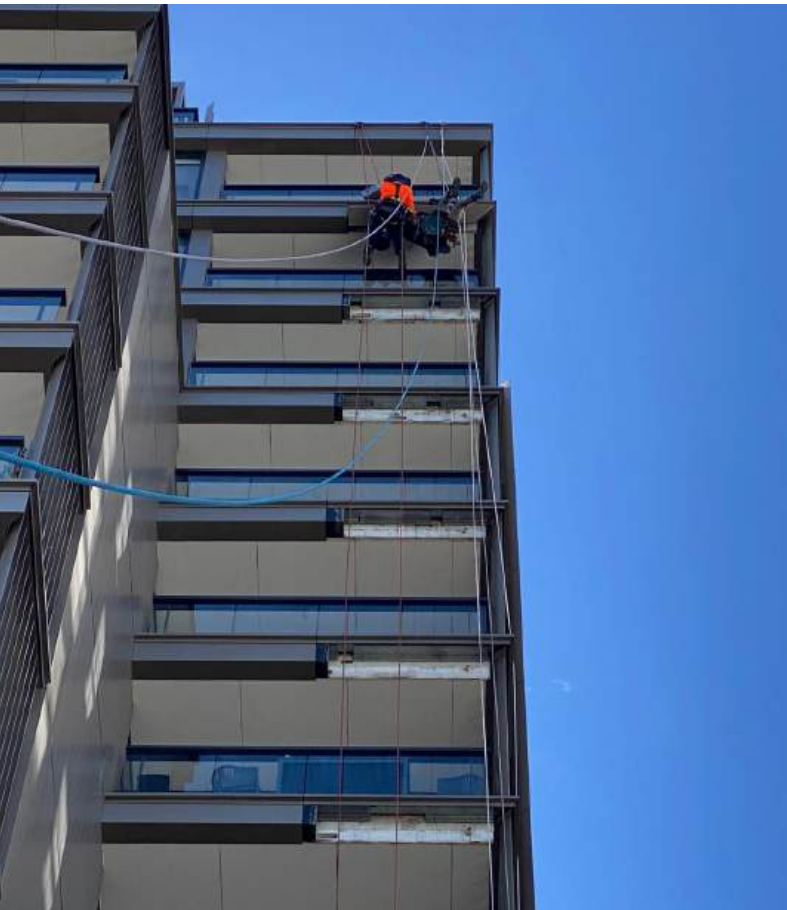
Rope access technicians installing ventilation grills

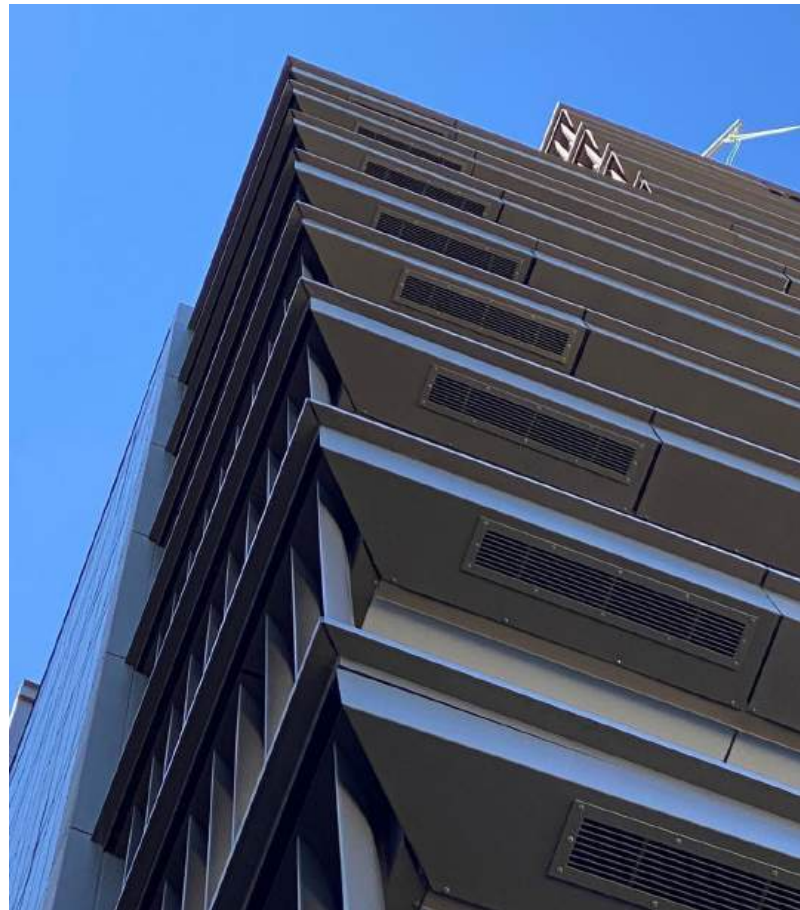
New ventilation grills installed on all levels

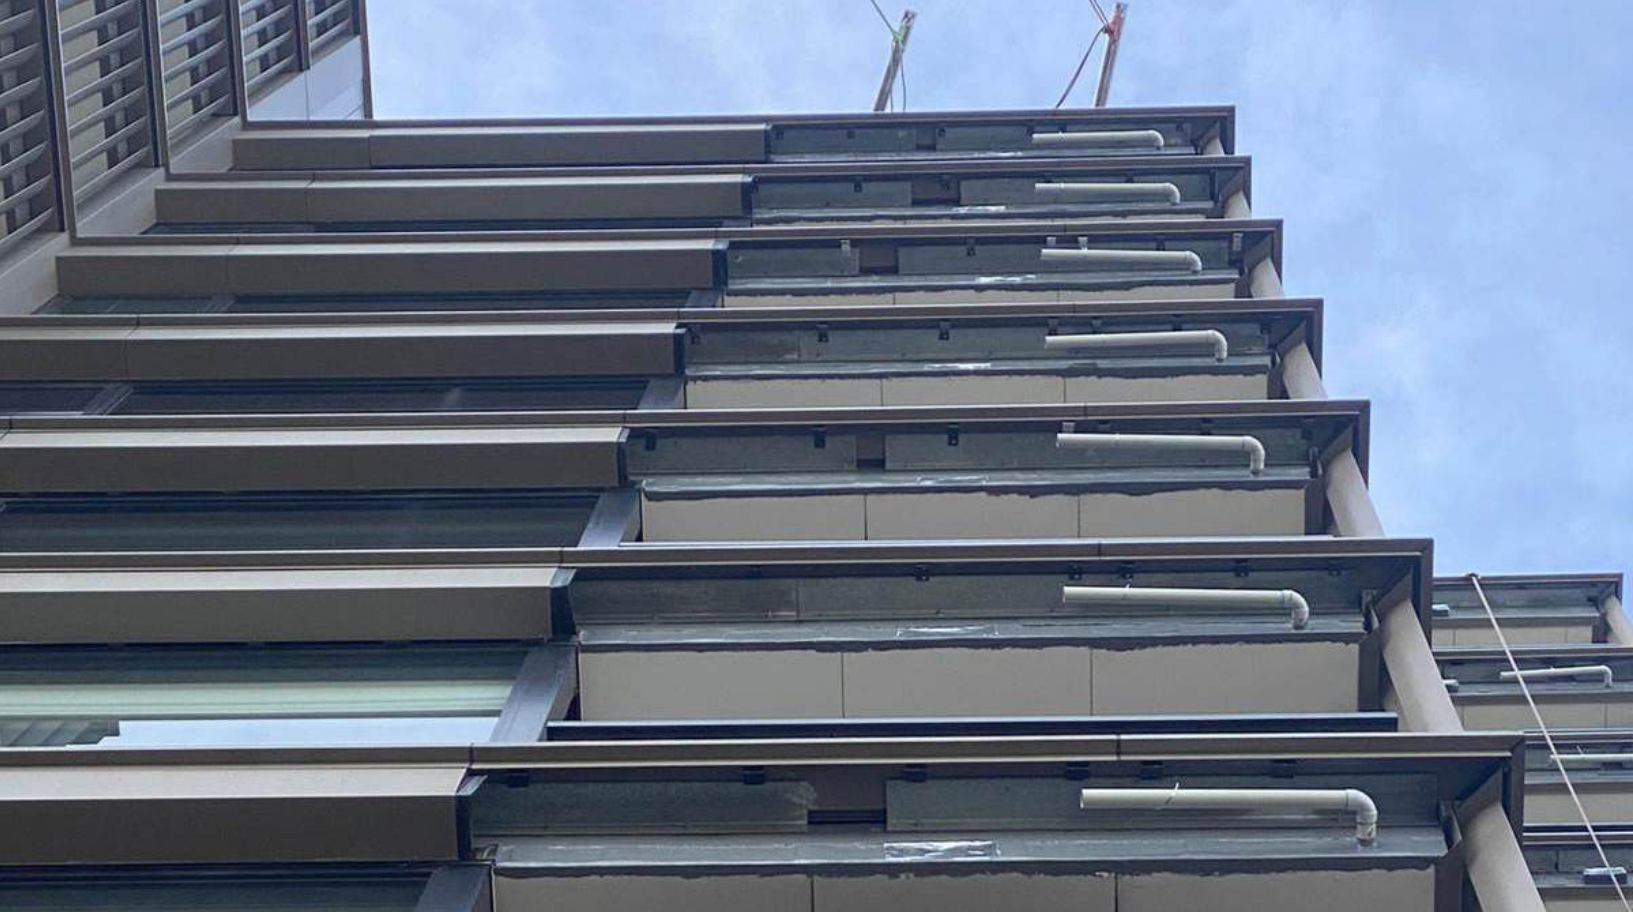
Integrated panels with each apartment's exhaust system.

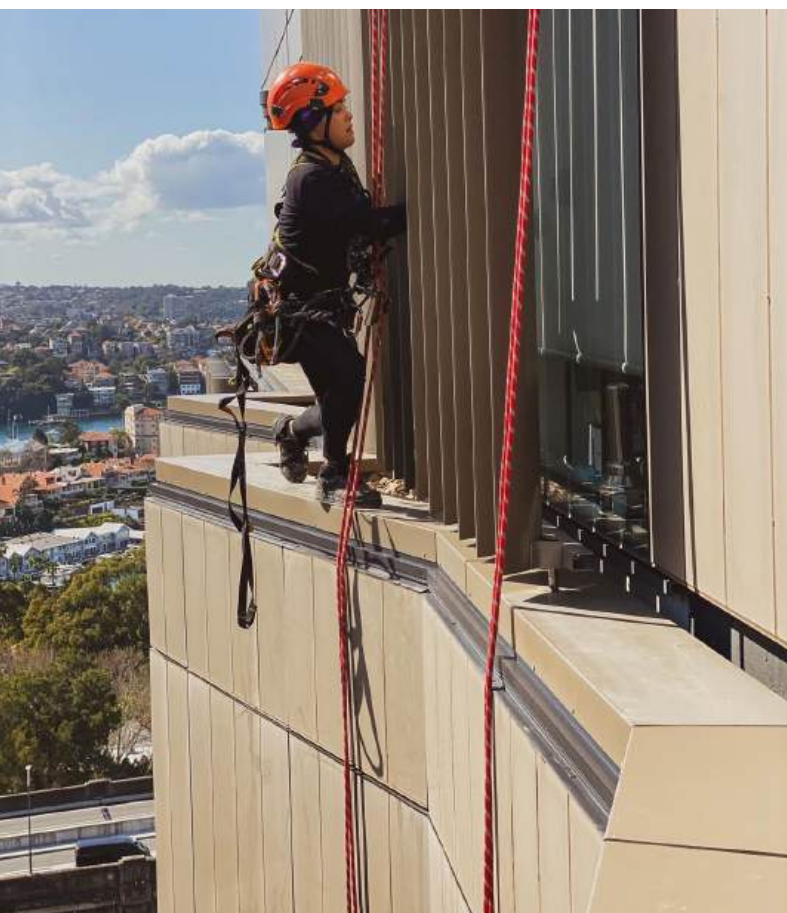
Rope access technicians installing cladding.
