Central Synagogue Atrium

Project: Facade Sealant Replacement & Water Ingress Investigation

Sector: Facility Management

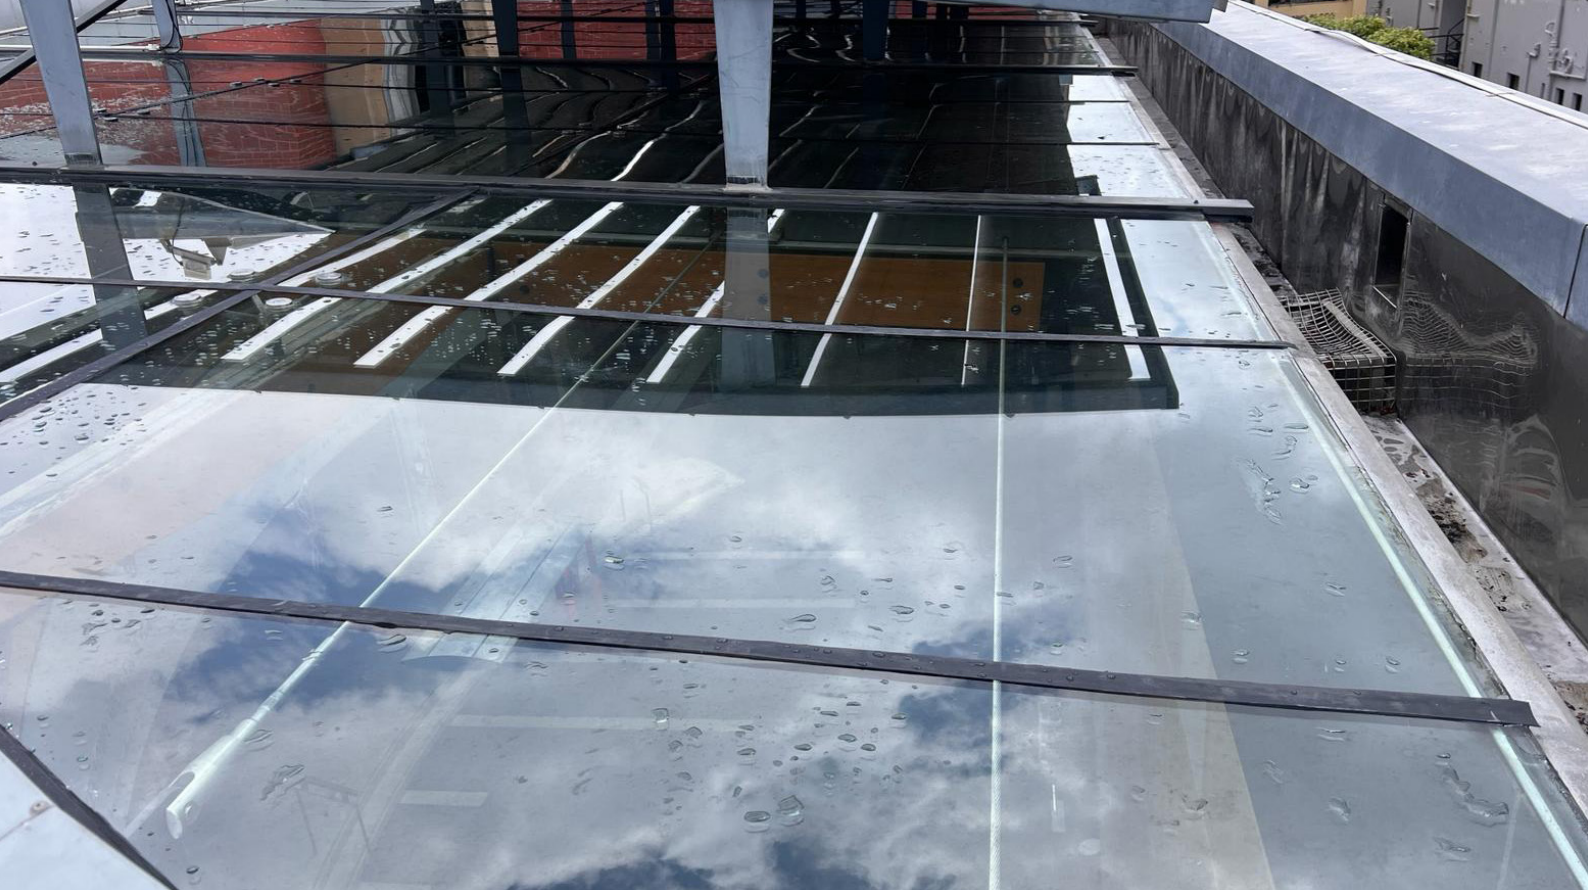
Effective application of the Tremco TREMGlaze 50 and Spectrem Simple Seal 1.5.

The original sealant between the glass joints and mullions was showing clear signs of deterioration, leading to both water ingress and visual discolouration. Using rope access, our team applied Tremco TREMglaze 50 to the joints, paired with Spectrem Simple Seal 1.5" Black for a clean and watertight finish. This premium system was chosen for its weather-resistant properties, long-term durability, and superior adhesion to glass and aluminium.

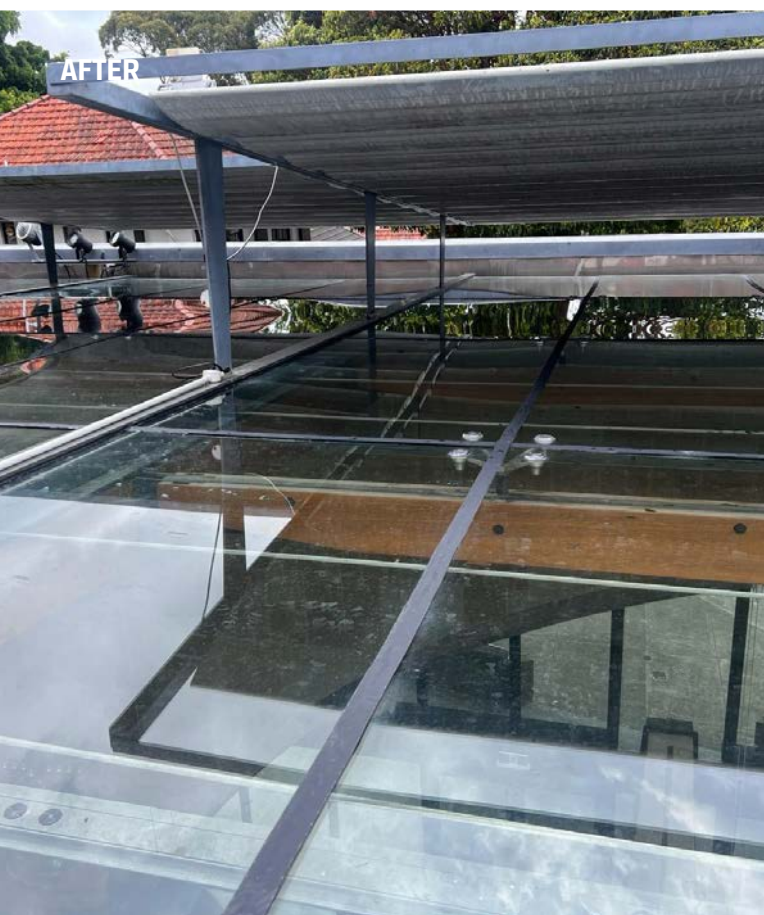
New sealant between all glass joints.

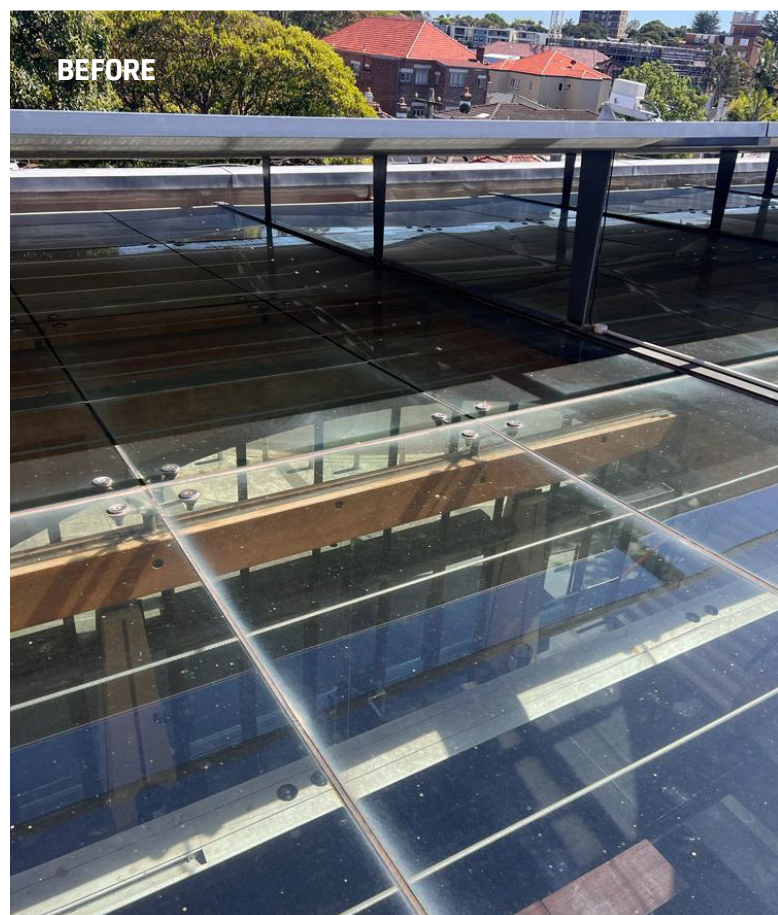
Old defective sealant on the Atrium of the Central Synagogue

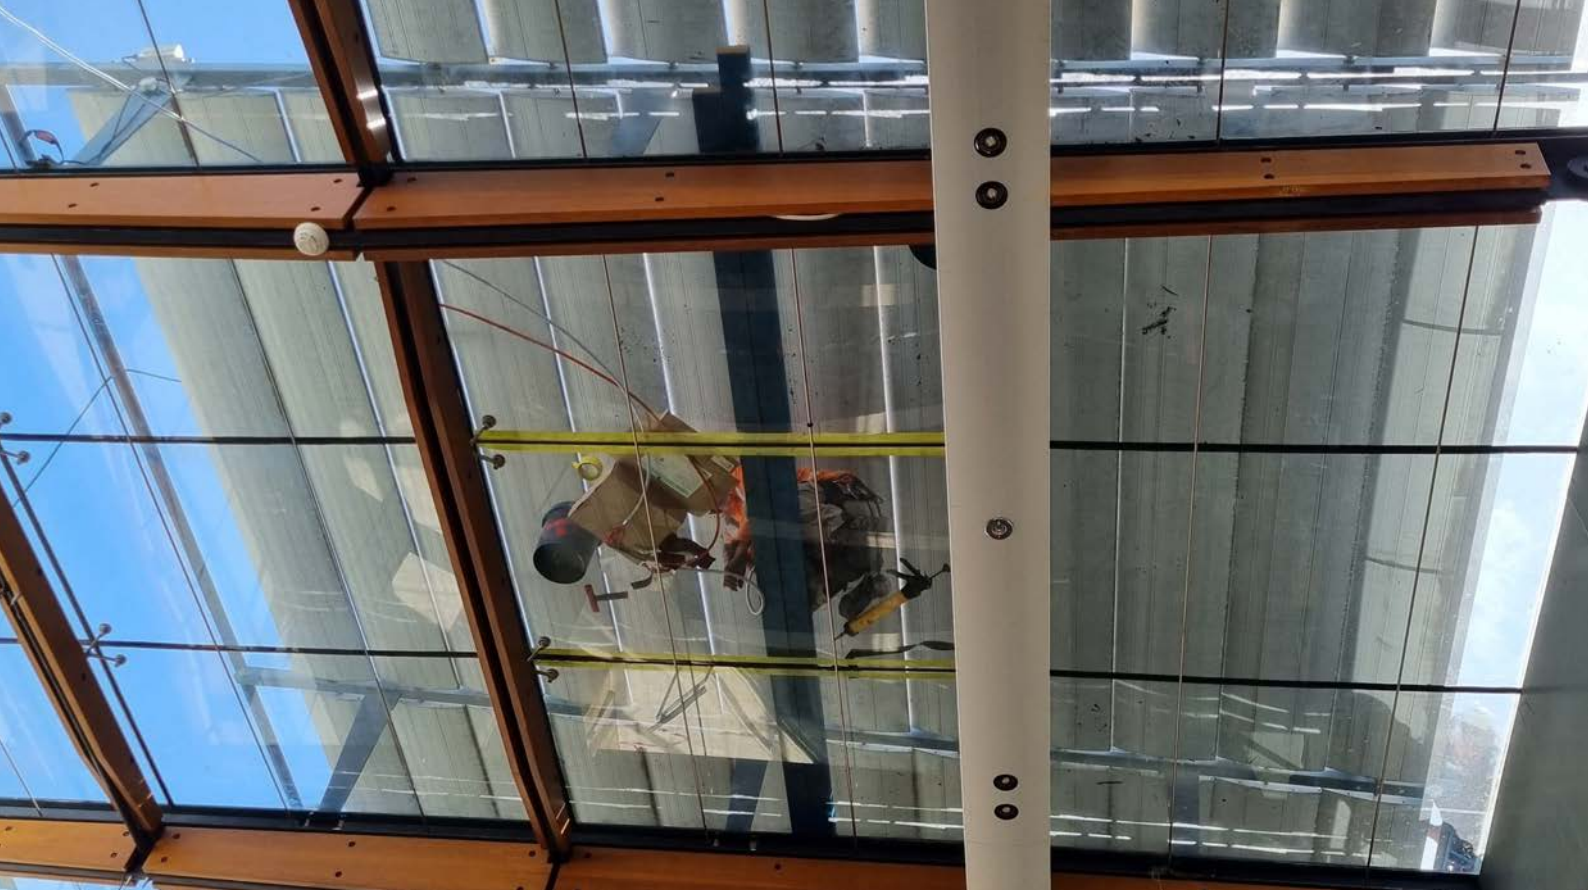
Our technicians in action applying the sealant

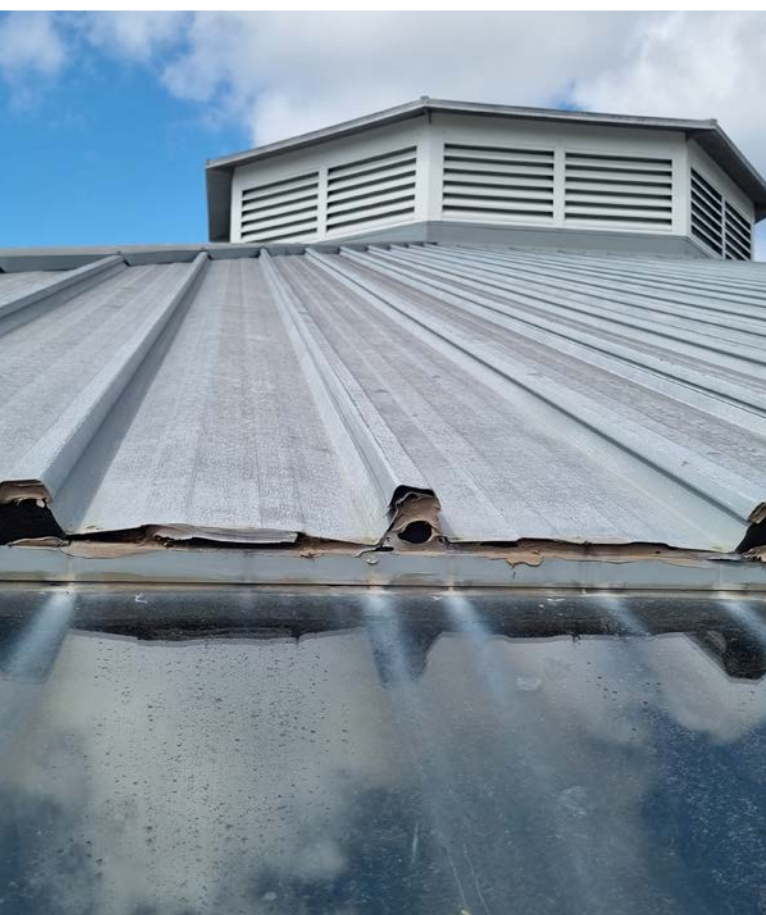
Inspection of perished barge capping to determine water ingress areas

- New pressure seal flashing, replacing deteriorated components
- A new rubber dektite to the exhaust pipe
- A fresh barge capping for long-term weatherproofing

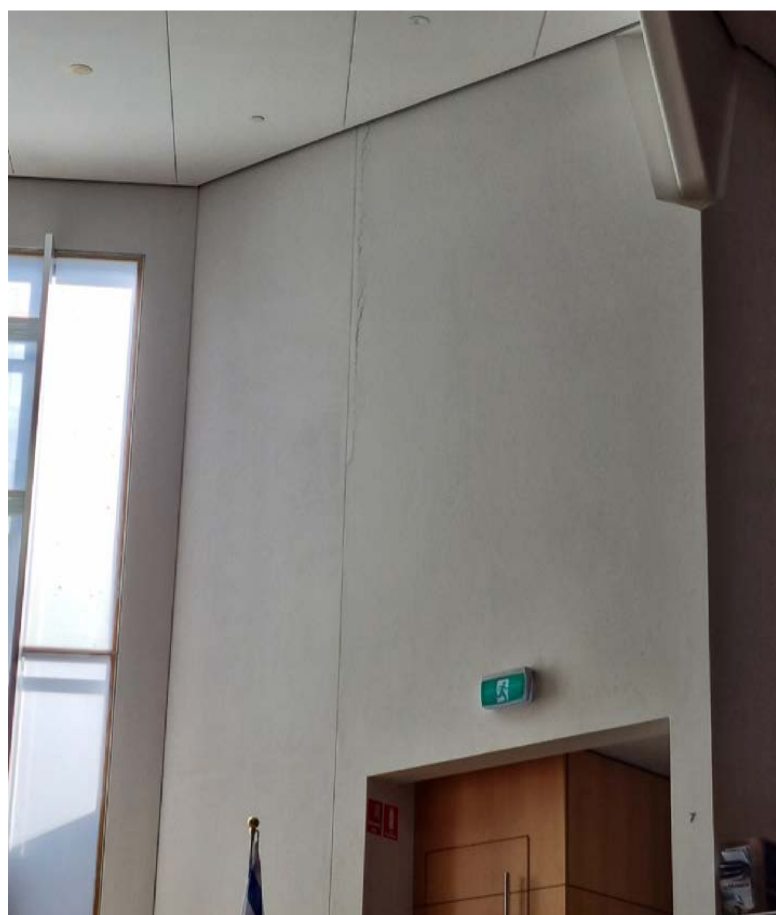
Water ingress damage on the inside of the atrium wall panels
