Sleep Health Specialist, Bella Vista

Project: Atrium sealant replacement

Sector: Facility Management

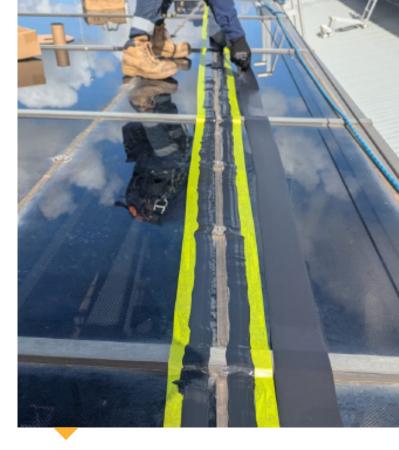
Applying the Tremco Simple Seal

The works included rope access and edge protection setup, surface preparation and cleaning, application of Simple Seal over existing joints and mullions between glazing panels, use of Spectrem® 1 silicone for superior adhesion and flexibility, ongoing monitoring to avoid environmental disruption during curing, and a full clean and reinstatement of the atriums glass feature.

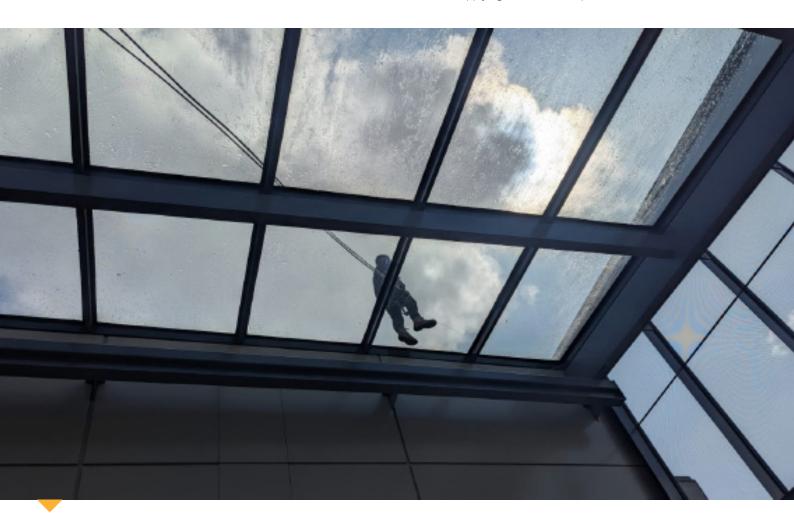
Surface preparation in progress

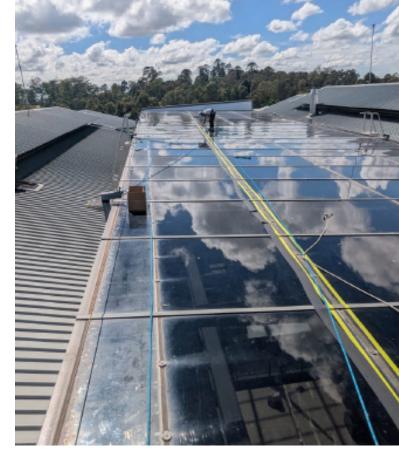
Surface preparation before applying Simple Seal

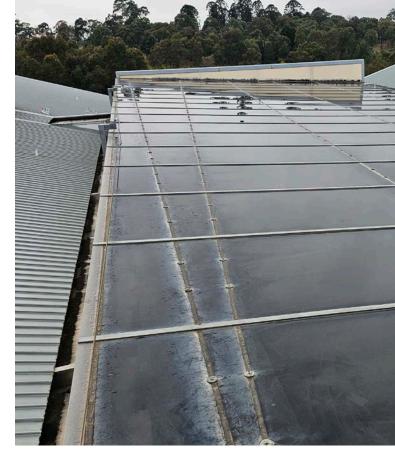
Image of the atriums perishing sealant around the mullion joints

Sleep Health Specialist in Bella Vista operates a major 30-acre research, development, and manufacturing campus, who engaged Anchor Safe Rope Access to address water ingress issues caused by perished sealant joints on their expansive atriums and skylight feature, covering more than 850 square metres. With a strong focus on aesthetics, performance, and durability, ResMed required a tailored, non-invasive solution that would enhance the professional appearance of the site while ensuring long-term protection —with minimal disruption to its high-functioning operations.

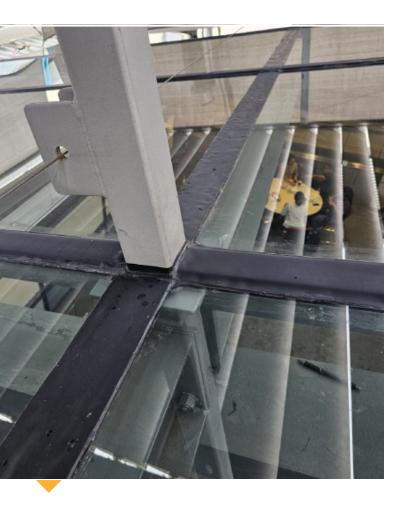
Applied Simple Seal to Atrium glass joints

Over four weeks, Anchor Safe Rope Access successfully completed the project, applying the Spectrem Simple Seal system to all targeted joints and sealing interfaces. This proactive upgrade will significantly extend the life of the atrium glass feature, reduce maintenance frequency, and protect against water ingress-all without disturbing the day-to-day operations of the health facility.

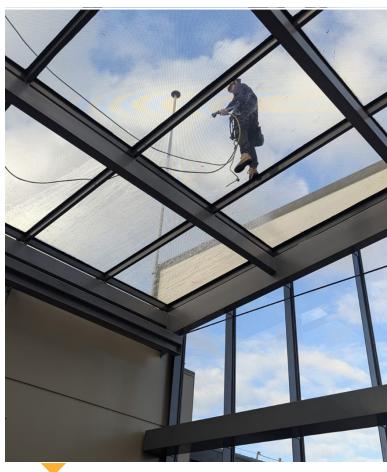
Post application cleaning
